# 2002 Annual Site Inspection and Monitoring Compliance Report for Uranium Mill Tailings Radiation Control Act Title II Disposal Sites

November 2002

Prepared by  
U.S. Department of Energy  
Grand Junction Office  
Grand Junction, Colorado

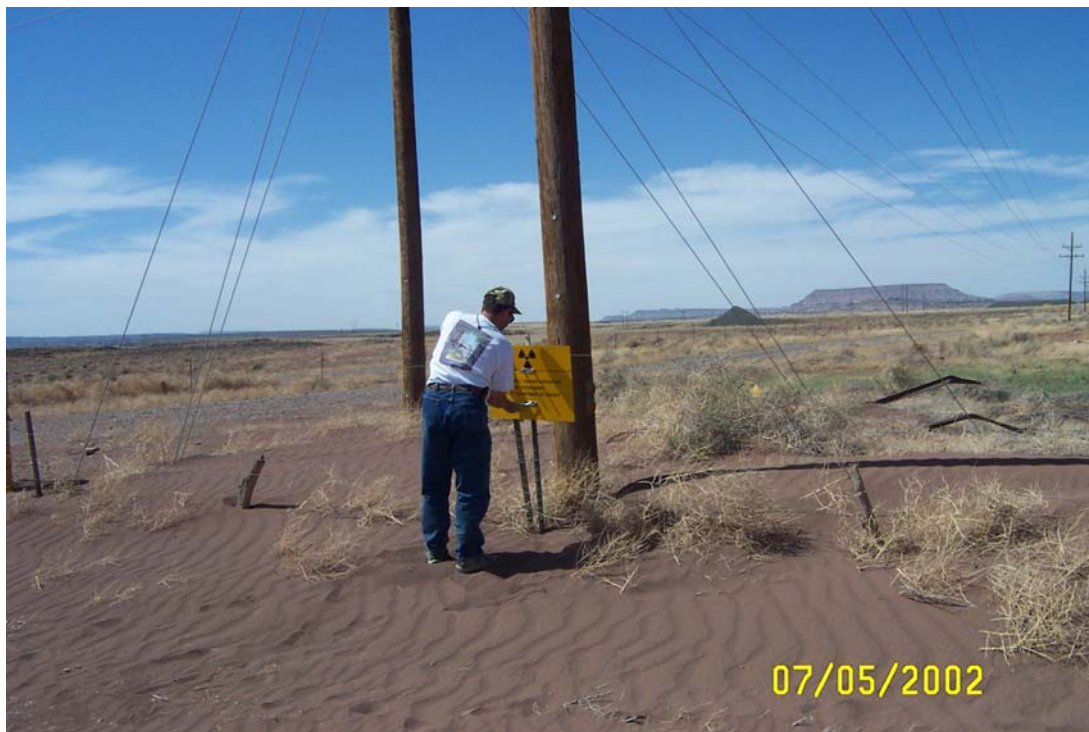
Fifty-four perimeter or warning signs, designated P1 through P52 on [Figures 1–1](#) and [1–2](#) (including perimeter signs P2A, P2B, P9A, and P9B), are posted at access points along right-of-way intersections with the site boundary and around the main and carbonate tailings disposal cells. At the Bluewater site, all signs are identical and convey the information typically conveyed on entrance signs at other Long-Term Surveillance and Maintenance (LTSM) Program sites. Perimeter sign P1, located at the access gate, was missing; inspectors replaced P1 (PL–1).

*BLU 5/2002. PL-1. Replacing sign at entrance gate. (Date shown is incorrect. Actual date is 5/7/2002).*

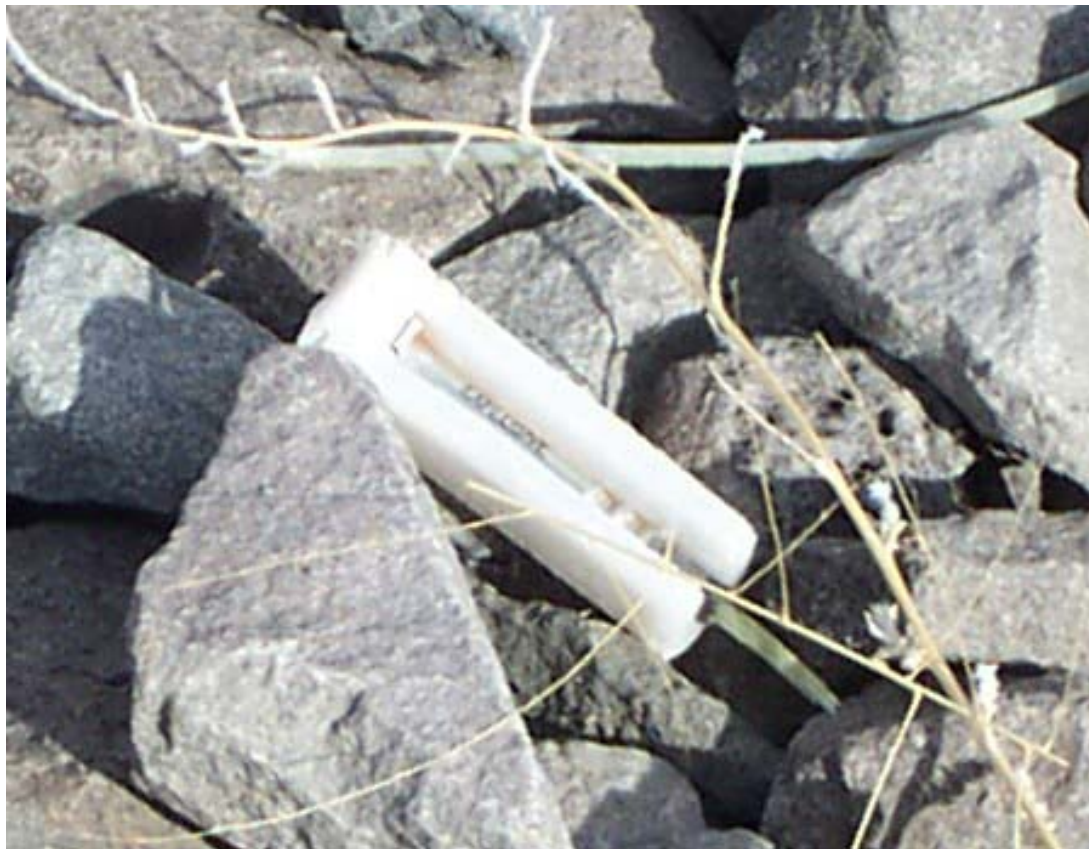
An unexploded blasting cap was found on the northwest edge on the top of the main tailings disposal cell. It was photographed (PL-2) so that inspectors could recognize other potential blasting caps and be cognizant of safety hazards. The blasting cap was not disturbed.

*BLU 5/2002. PL-2. Unexploded blasting cap.*

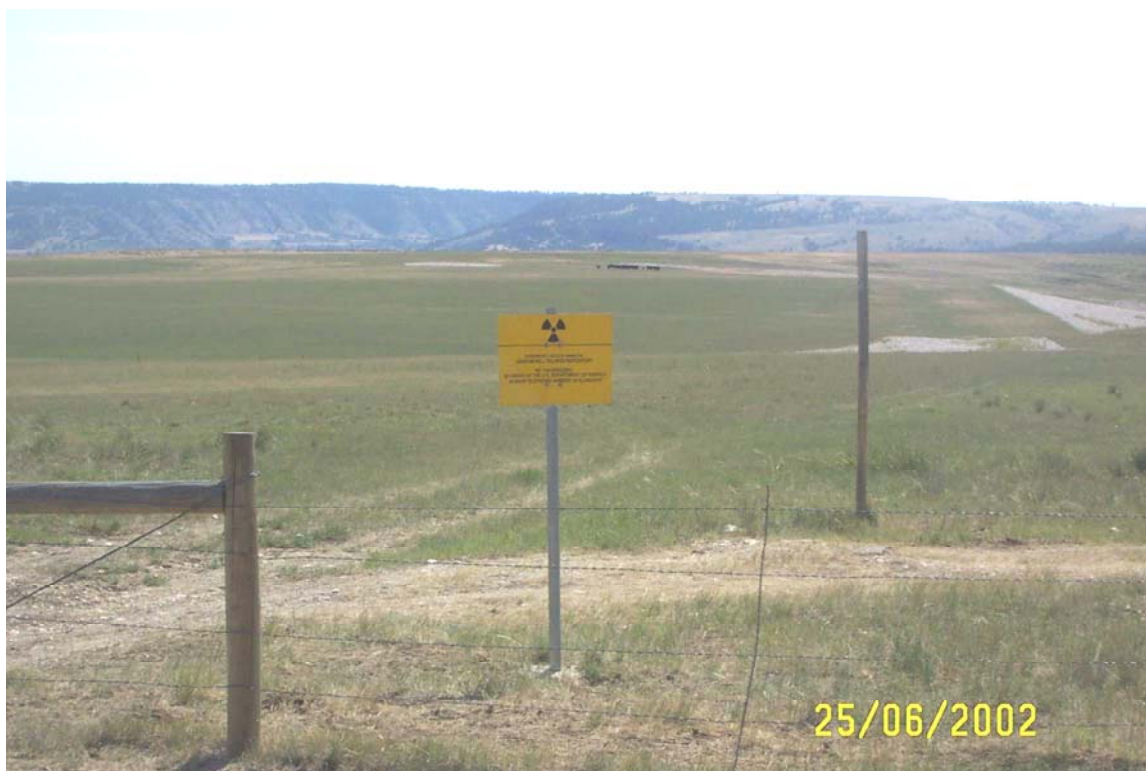
The tubular metal entrance gate is secured by a padlocked chain and is in excellent condition. The site marker and site entrance sign (PL-1) also are in excellent condition.

*EDG 6/2002. PL-1. Entrance sign.*

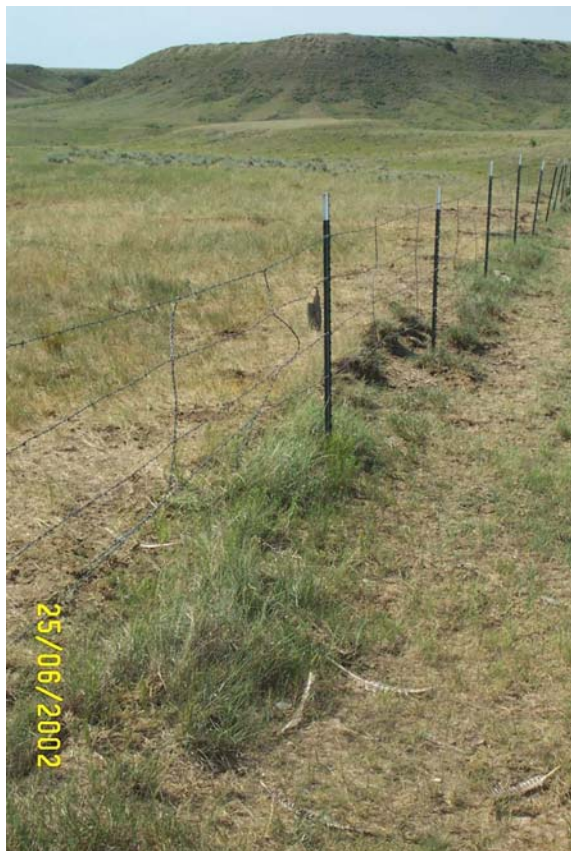
A four-strand barbed-wire fence was installed in spring 1999 along the site boundary to demarcate DOE property and to control grazing on the property. The entire fence line was walked to inspect the fence and the boundary monuments. Minor fence repairs may be necessary at two locations. The wire was stretched on the west property boundary (PL-2) and the fence wire was loose where a metal tee post has pulled out of the ground along the south property boundary. However, based on the condition of the range inside the fence on site property versus outside the fence, the fence is adequately preventing unauthorized grazing. Therefore, fence repairs are not considered critical at this time. DOE will ask the grazing permittee to repair the fence at these locations. Otherwise, the fence is in excellent condition. Three livestock watering tanks were present on site during the inspection (PL-3). The tanks had been filled recently.

*EDG 6/2002. PL-2. Stretched/loose fence  
along west boundary.*

The Edgemont disposal site is in good condition at this time. Minor fence repairs are in order but the fencing is performing as required, therefore the fence repairs are not critical at this time. Vegetation colonizing the riprap will continue to be monitored during future inspections.

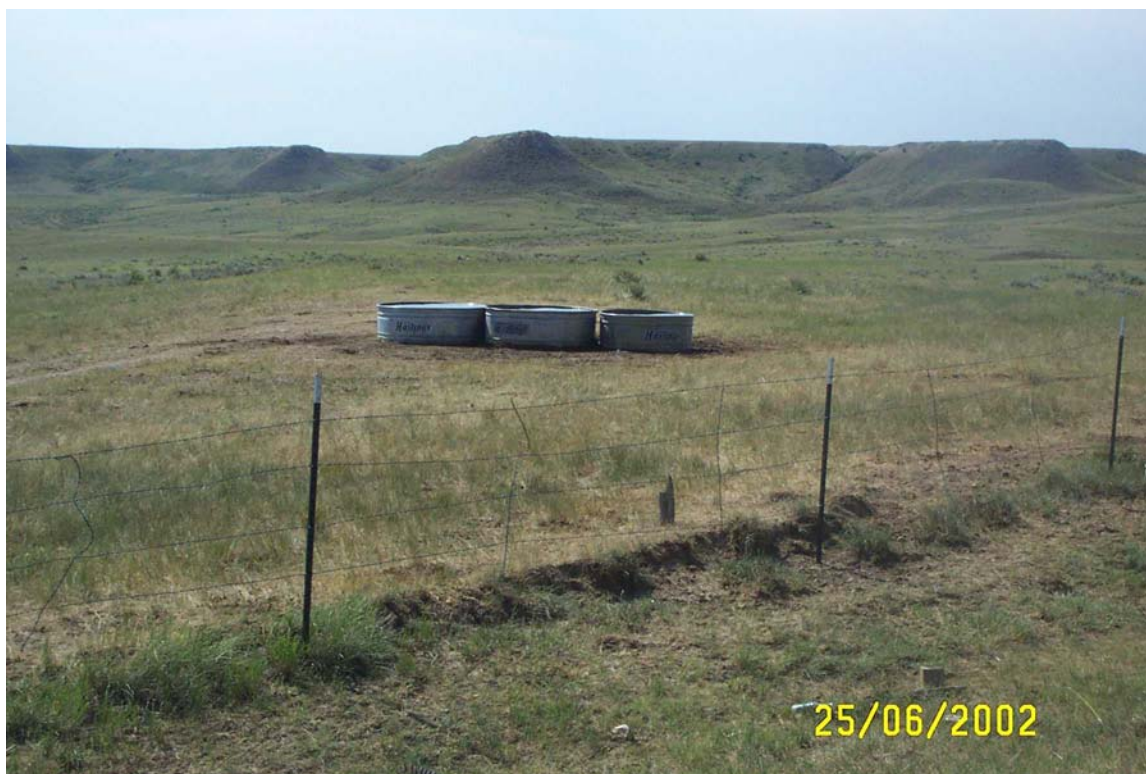
*EDG 6/2002. PL-3. Livestock watering tanks.*

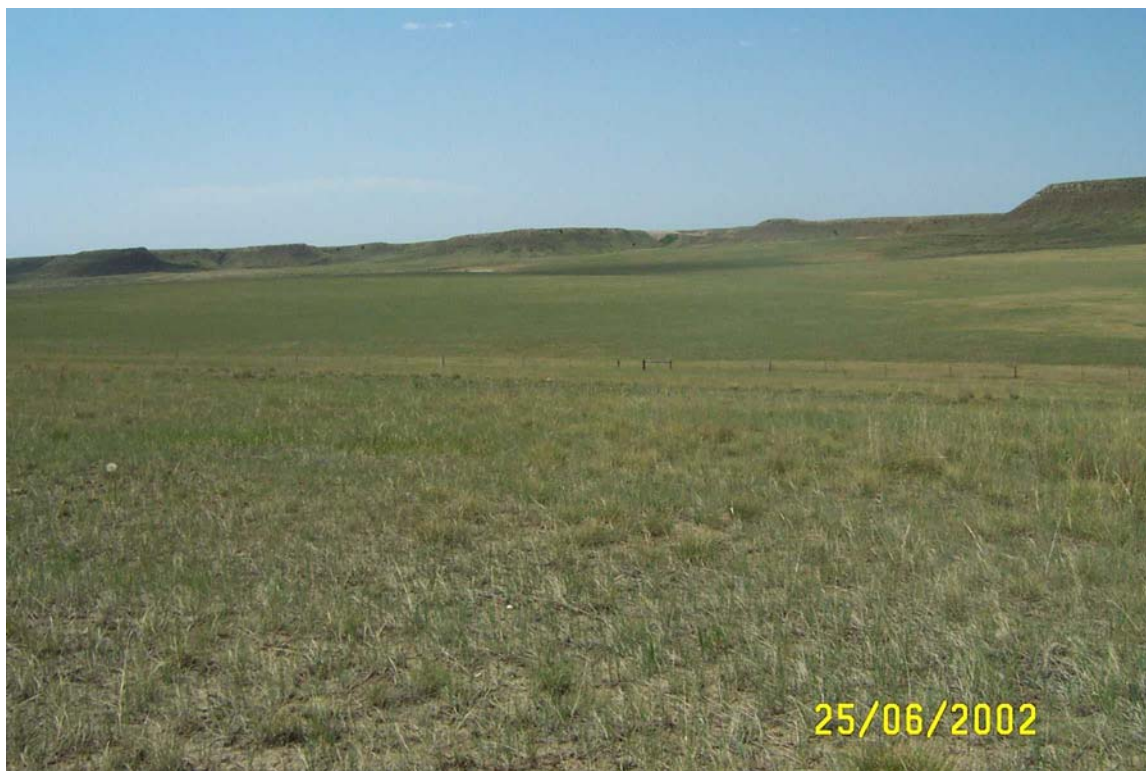
*EDG 6/2002. PL-4A. Disposal cell cover, looking southwest.*

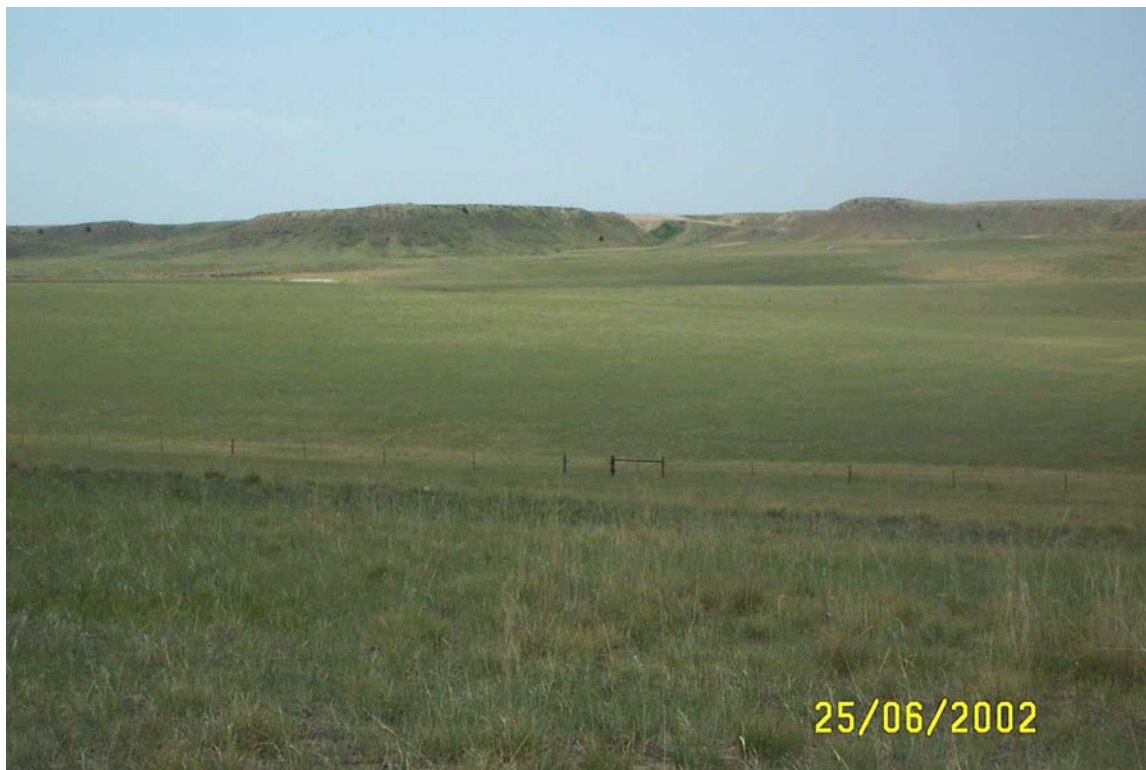
*EDG 6/2002. PL-4B. Disposal cell cover, looking west.*

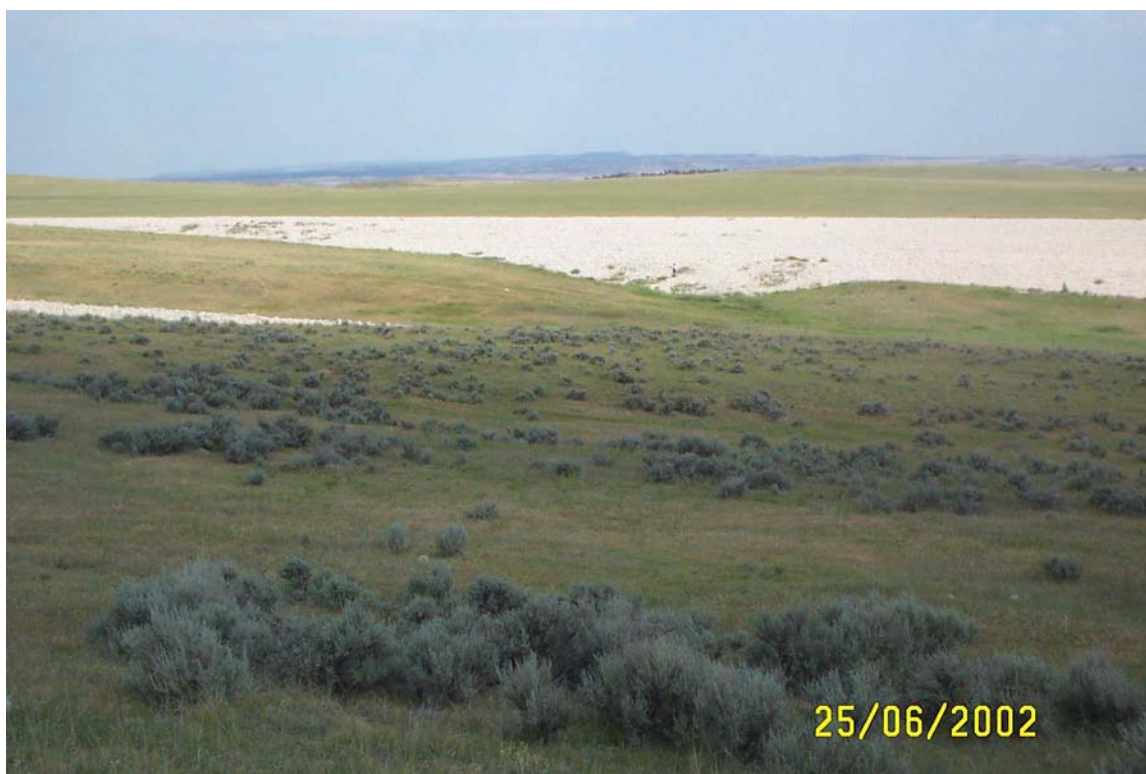
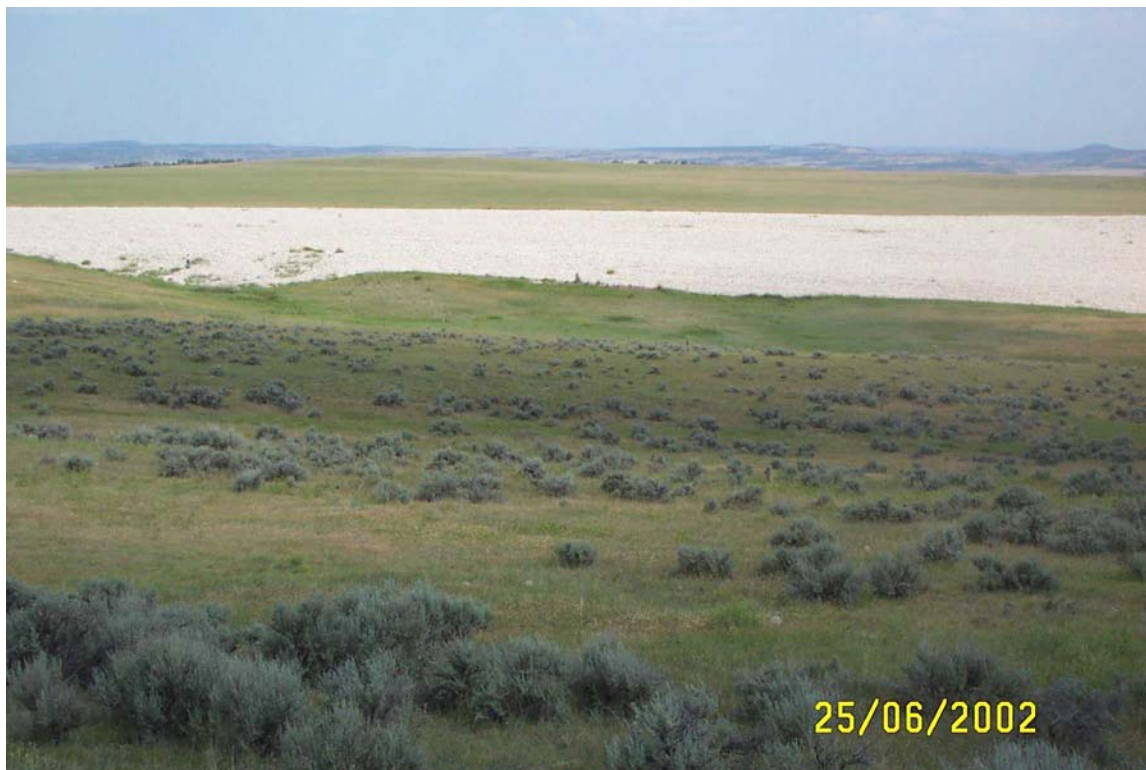
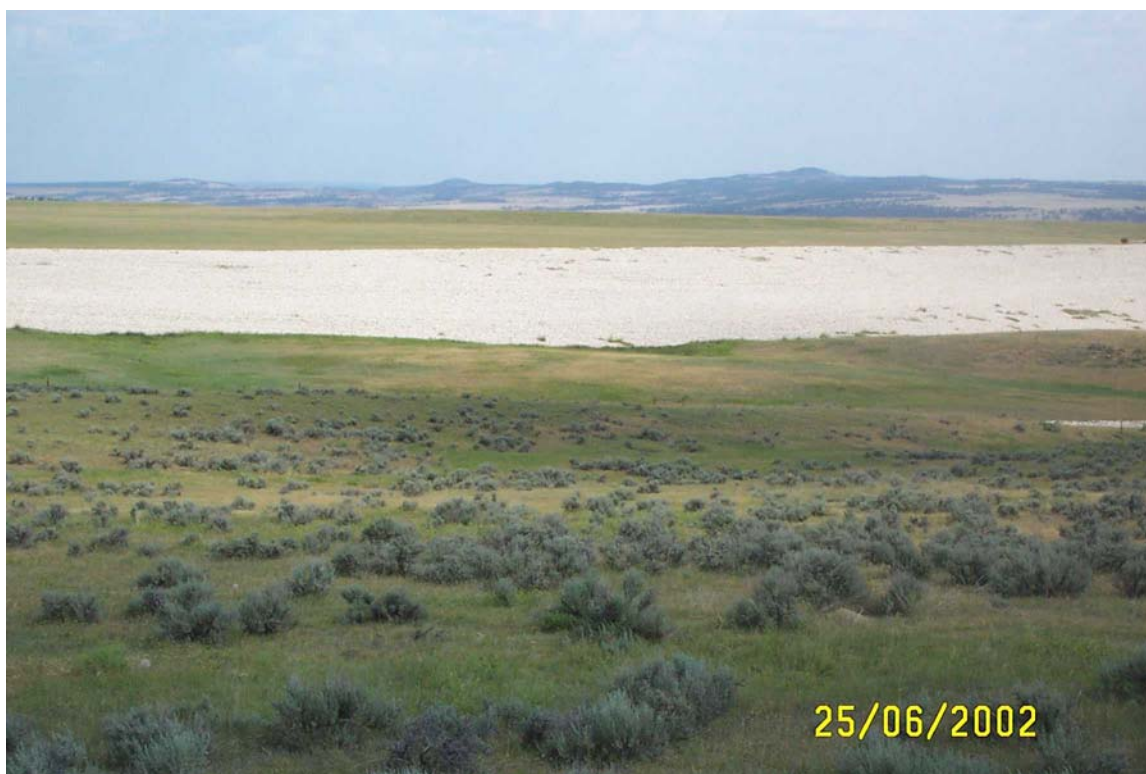
The tailings dam face is covered with riprap and represents the steepest slope on site. The slope is stable and the riprap shows no signs of degradation. Scattered plants, mostly grass, grow in the riprap (PL-5A, PL-5B, and PL-5C). These plants do not pose an immediate threat to stability or function of this structure. The plant density has not increased over the last few years. Plant density in the riprap dam face will continue to be evaluated during future inspections.

*EDG 6/2002. PL-5A. Embankment face showing plant encroachment.*

*EDG 6/2002. PL-5B. Embankment face showing plant encroachment.*

*EDG 6/2002. PL-5C. Embankment face showing plant encroachment.*

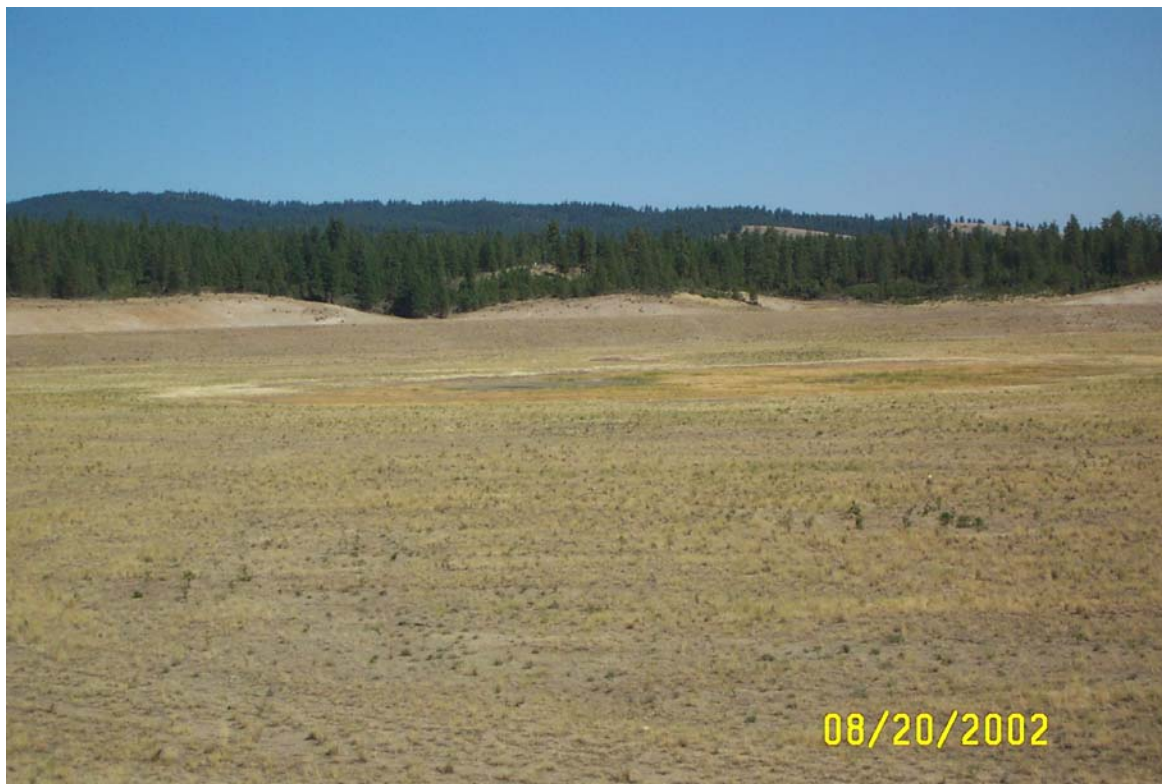
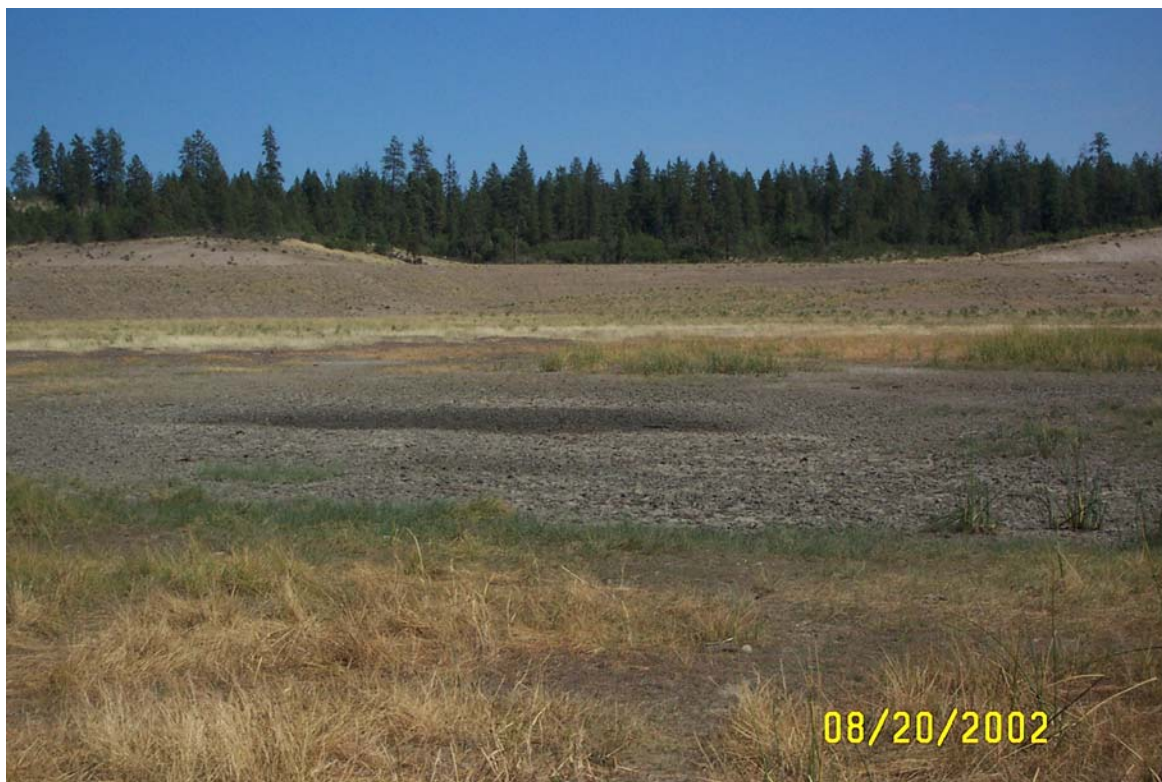
The tailings impoundment cover for the Sherwood site consists of 12 to 20 feet of uncompacted soils. During site reclamation, surface soils were seeded and planted with shrubs, forbs, grasses, and trees. Reclamation has been successful, as a healthy stand of vegetation is now established. Inspectors walked traverses across the impoundment cover and found no evidence of differential settlement other than the pond area observed during earlier inspections. The pond area did not appear to have expanded in size (PL-1 and PL-2).

The pond area was dry at the time of the inspection; however, the plant species present indicate that there is year-round moisture below the surface. Vegetation in the pond area is composed primarily of native wetland species such as hardstem bulrush (*Scirpus acutus*), Olney threesquare (*Scirpus americanus*), common spikerush (*Eliocharis palustris*), sandbar willow (*Salix exigua*), and plantain (*Plantago eriopoda*). The pond provides habitat for small mammals, birds, and reptiles and appears to be a water source for larger mammals such as deer and elk, whose sign was abundant in this area.

*SHE 8/2002. PL-1. Pond area on top of tailings impoundment.*

*SHE 8/2002. PL-2. Pond area on top of tailings impoundment.*

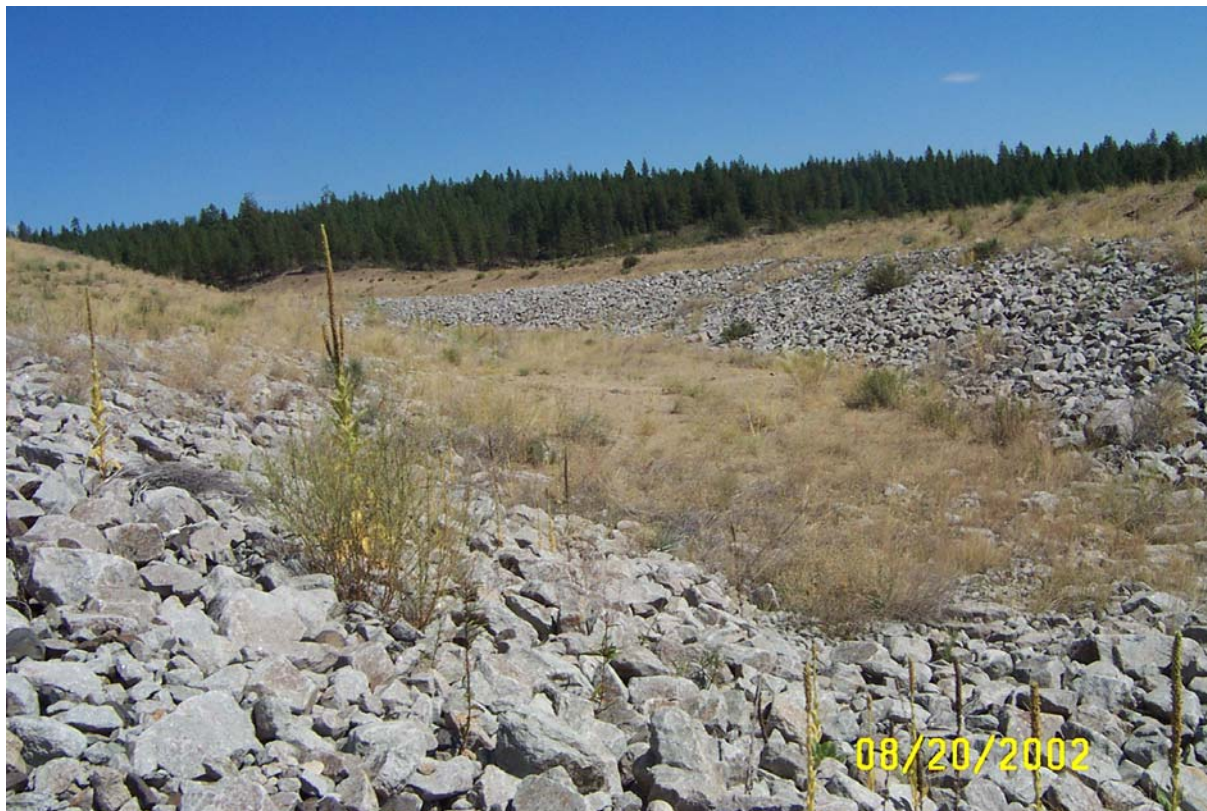
*SHE 8/2002. PL-3. Sediment in west drainage channel.*

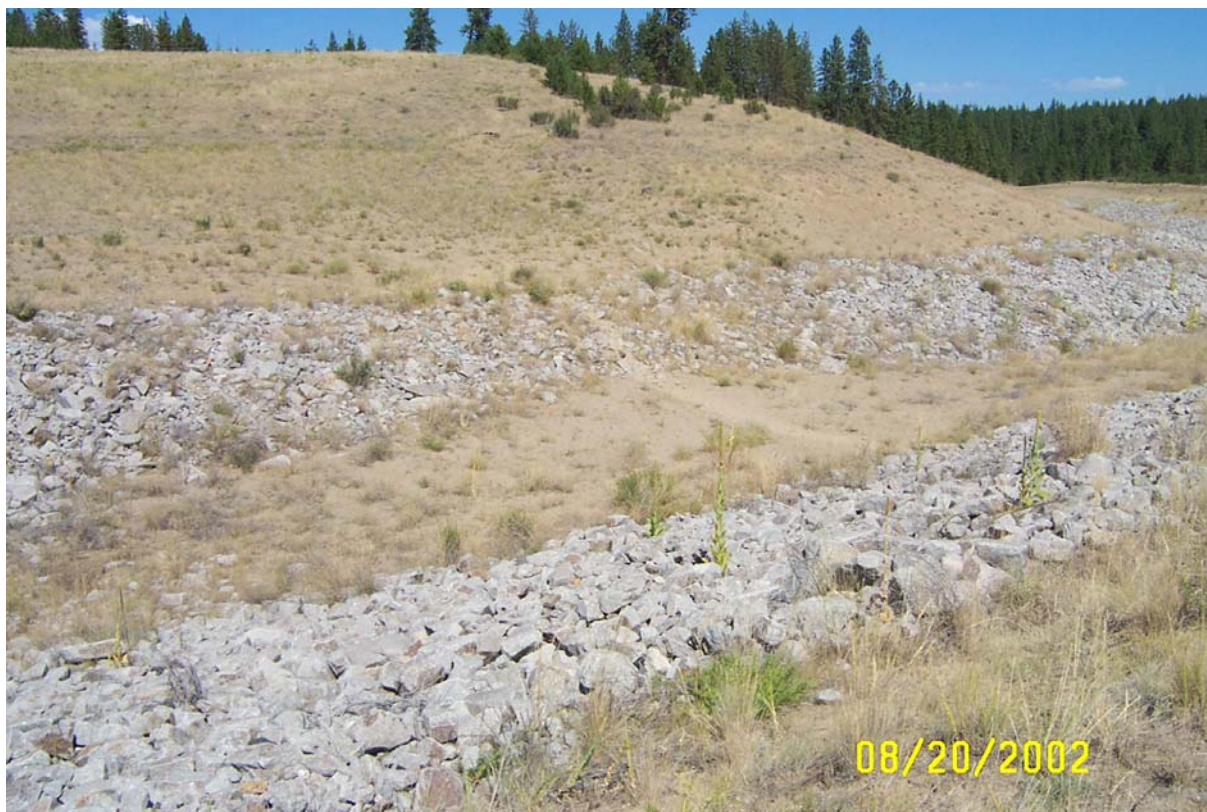
*SHE 8/2002. PL-4. Sediment in west drainage channel.*

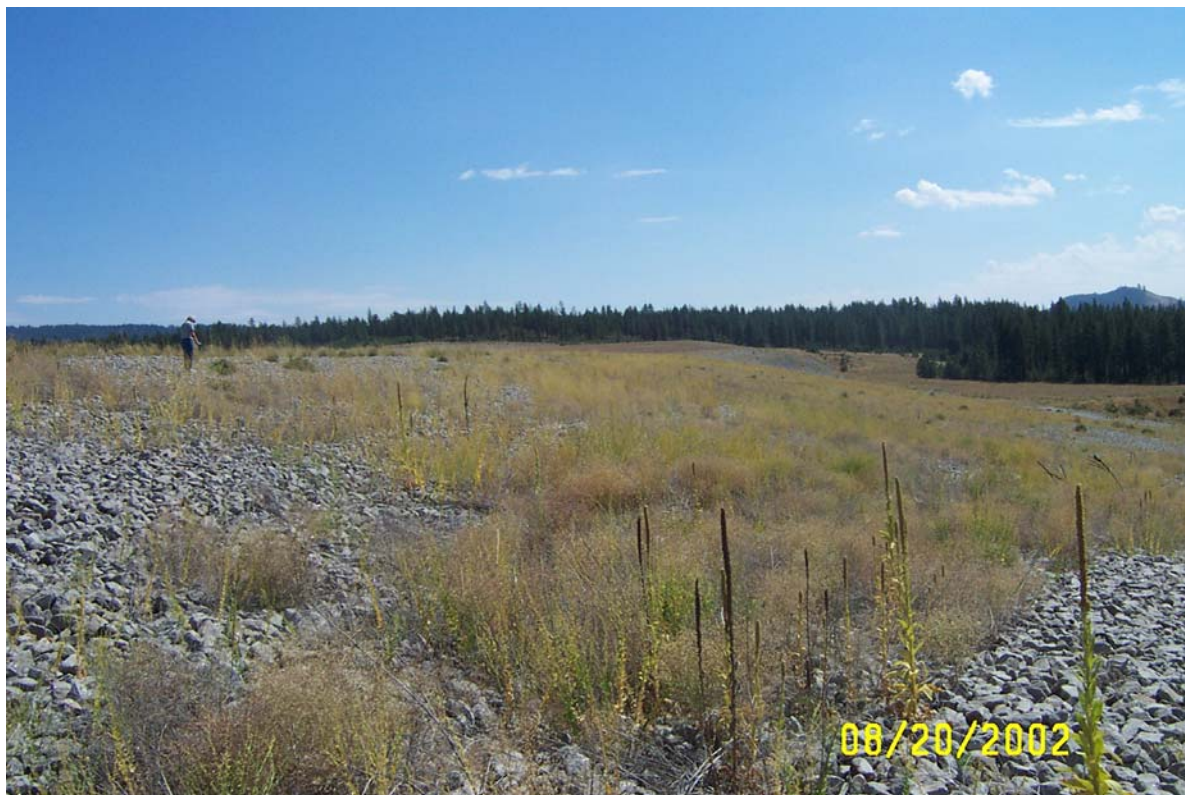
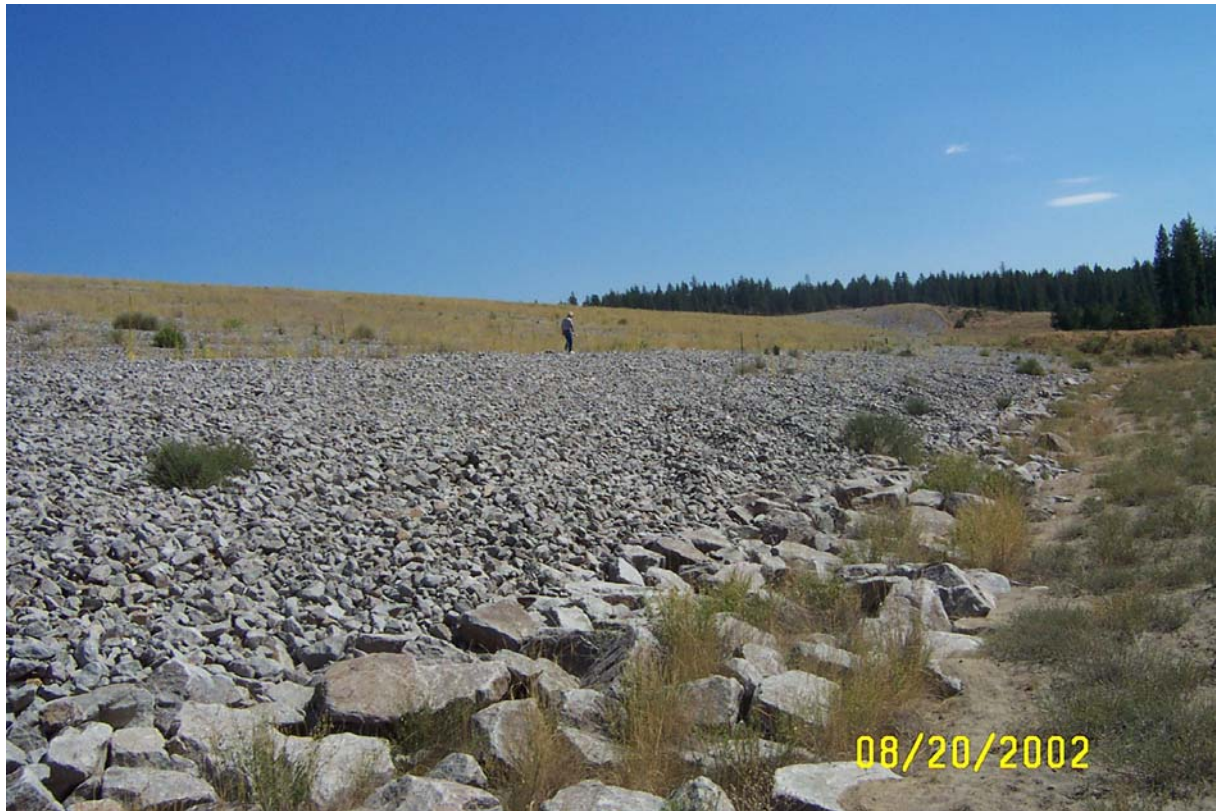
The impoundment dam face was inspected in accordance with the appended Dam Inspection Checklist ([Appendix A](#)) and photographed (PL-5, PL-6, and PL-7). No evidence of seepage, slumping, erosion, or instability was observed. Ponderosa pines, some as tall as 18 inches, were observed on the face. As these grow in size, they may need to be cut to prevent potential damage to the dam face from blow-down.

The NRC representative, concerned about rock durability, noted that rocks on the western portion of the dam face appeared to be more weathered than those on the eastern portion. He recommended that DOE institute a rock monitoring program for approximately 5-10 years. He suggested a visual observation method whereby photographs of "rock plots" would be taken at selected locations along the dam face on an annual basis.

*SHE 8/2002. PL-5. View of dam face.*

*SHE 8/2002. PL-7. View of dam face.*

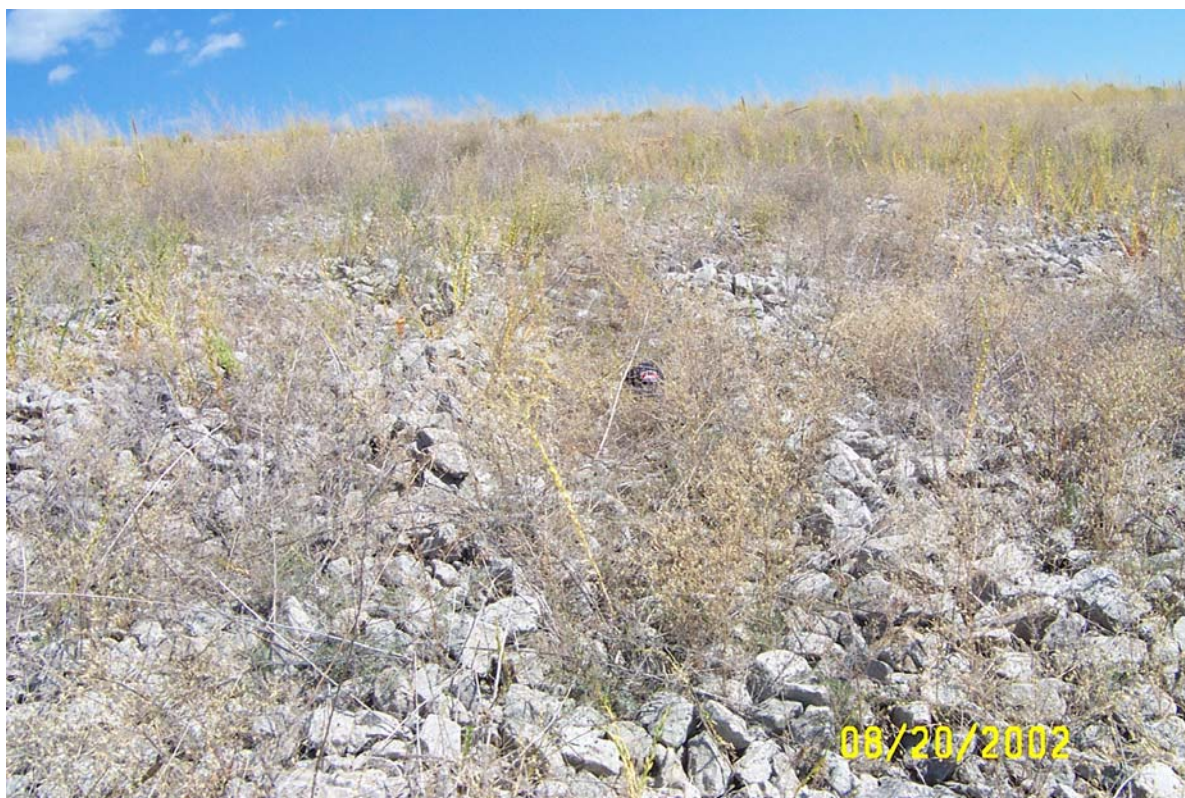
*SHE 8/2002. PL-6. Vegetation on dam face.*

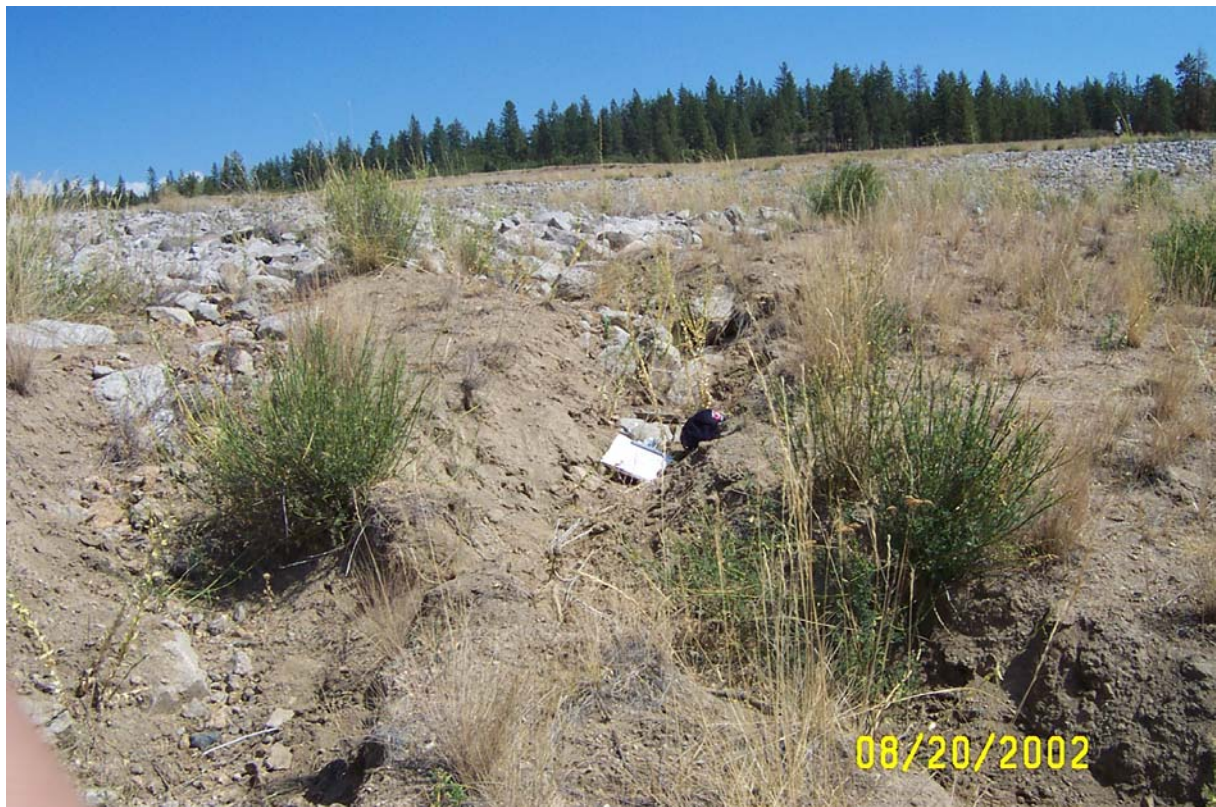
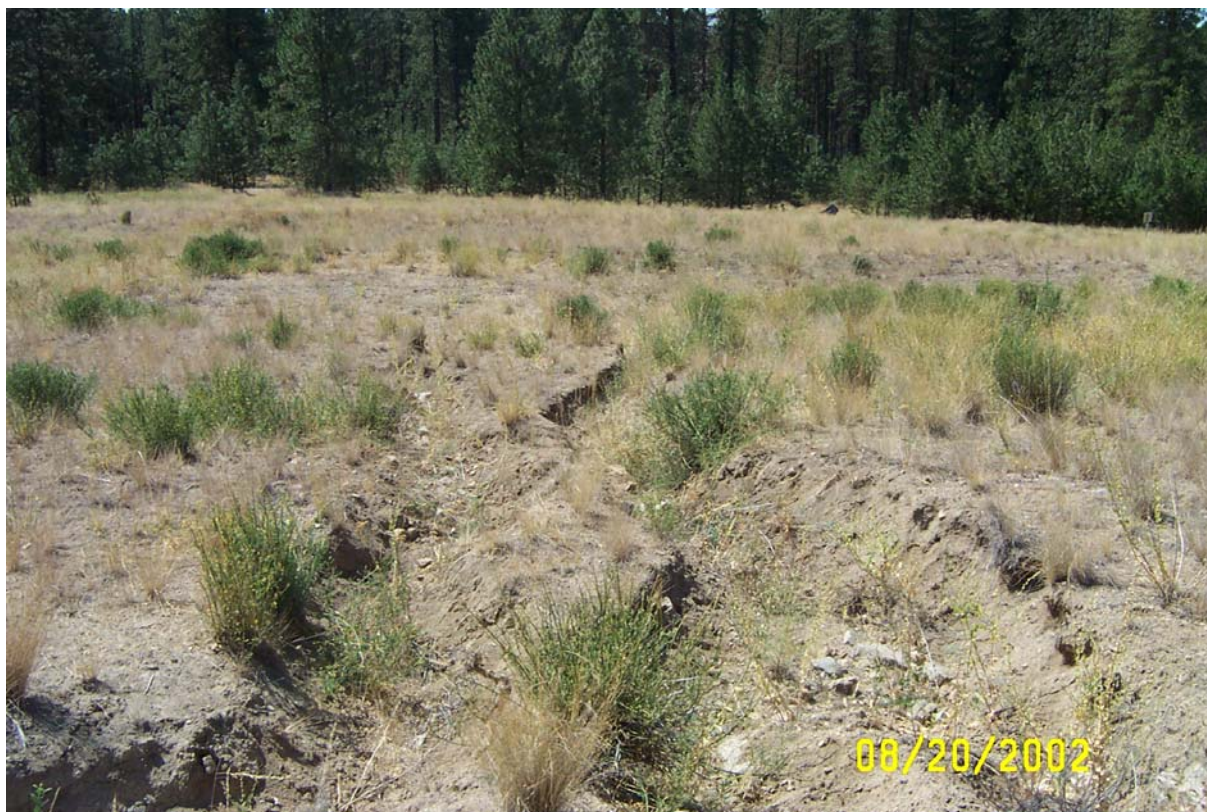
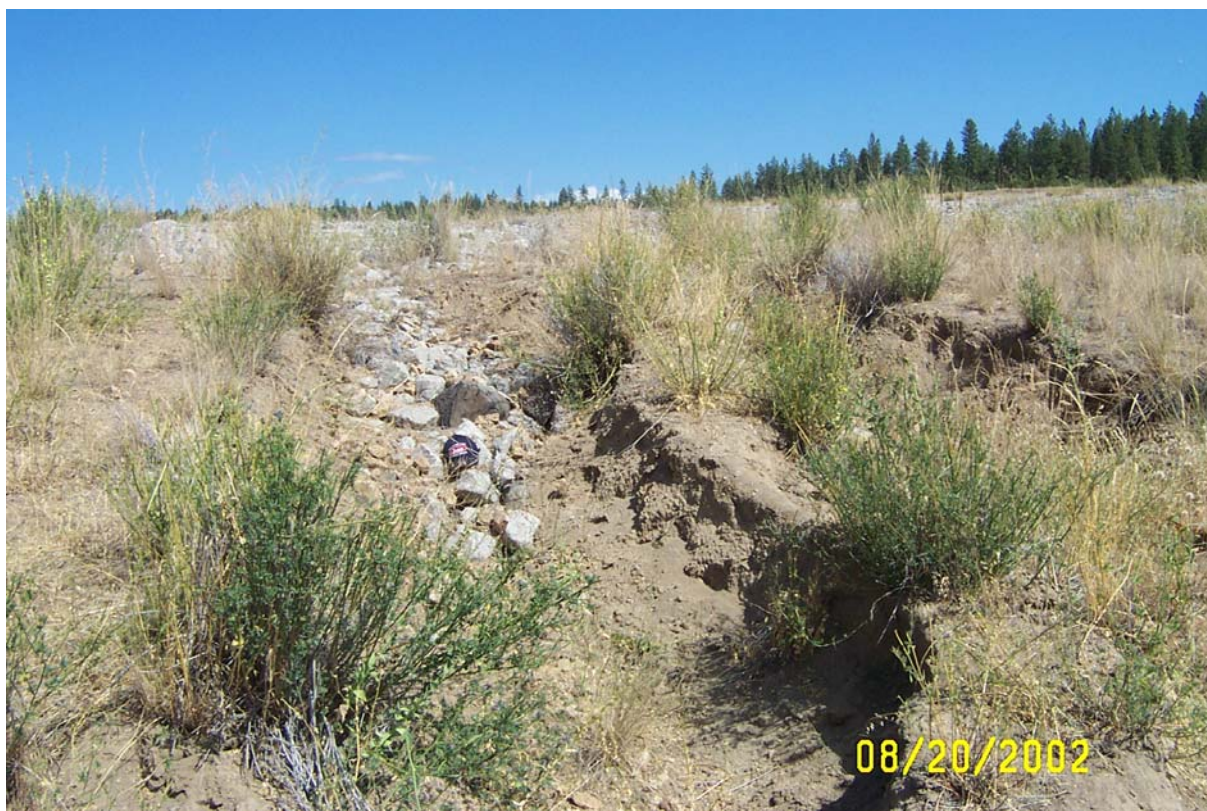
Adjacent to the eastern end of the dam face is a steep slope that is underlain by rock covered with soil. Numerous rills and gullies noted during previous annual inspections were inspected on this slope (PL-8, PL-9, and PL-10). No new rills were identified and the size of existing rills had not increased since the 2001 inspection. Although these erosional features do not pose a hazard, they should be inspected annually to ensure that the slope remains stable.

*SHE 8/2002. PL-8. Erosion on steep slope*

*SHE 8/2002. PL-9. Erosion on steep slope*

*SHE 8/2002. PL-10. Erosion on steep slope*
